Manhole Inspection Summary

Manhole # S17K__005MH

Location Address: **2426 franklin-alley-catherine** Cross Street: **s catherine st**

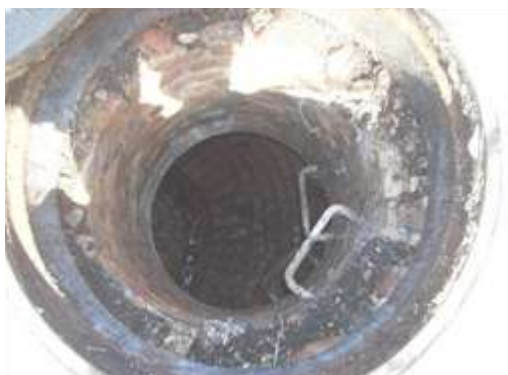
Defect 2

Frame Offset: **4** (in.) Condition: ☒ Sound ☐ Cracked ☐ Leaks

frame is offset all the way around

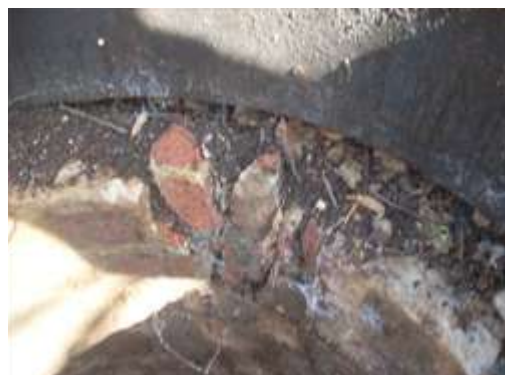
Defect 1

Chimney / Frame Adjustment ☒ Exists Material: **Brick** ☐ Parged Height: **3** (in.)

Condition: ☐ Sound ☐ Cracked ☐ Root Intrusion ☐ Loose Brick ☒ **Deteriorated**

deteriorated chimney

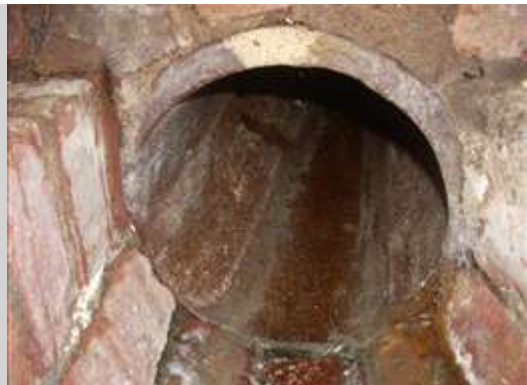
6 O'Clock Inflow

8 in. Circular Gravity Sewer
Pipe In @ 6 O'Clock

Pipe Height: **8.4** (in.) Rod and Bar (Angled)
Pipe Material: **Clay** ☐ Pipe Lined
Invert Depth: **7.81** (ft.) Flow Characteristics: **Slow**
Deposits: ☒ None ☐ Mud ☐ Sludge ☐ Debris ☐ Grease
Silt Depth: **0** (in.) Deposits Extent:
Infiltration: **None** Pipe Seal Cond: **Broken**
